## **MAGGOT, A REMARKABLE RHINOCEROS**

## RHINOCEROTIDAE CERATHOTHERIUM SIMUM, SIMUM WHITE RHINOCEROS

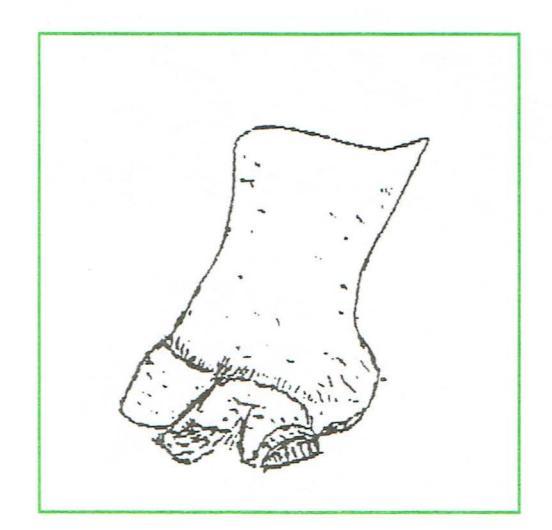
The patient's name is "Maggot", female and approximately twenty eight (28) years old, her estimated weight is two tons. The initial assessment revealed, a severe division of the toenail on the lateral aspect of the left front foot, (see Fig. 1 & 2).

the matrix could impair the blood flow and could cause irreversible damage to that part of the foot. The major concern with this in mind was to minimize the loading on the lateral toenail and cut away all the nail that was deformed and unable to function correctly, obviously leaving enough to attach the plate, fortunately this was possible due to the fact that the horn structure on both sides of the crack was bending from the mid-portion of

the nail (see Fig 1) leaving a good area for attachment of the plate.

The fact that we had no data on the growth rates of rhino toenails, it was agreed that a stainless steel plate be fastened as far up the toenail as was possible and would be fixed with stainless steel self tapping screws and be assisted with an acrylic compound (**Bond-N-Flex**<sup>®</sup>). The main reason for this decision was that if the growth rate was comparable to that of a horse, or elephant (approximately 8mm to 10mm per month) we could be placed in a serious situation in terms of loading by applying a shoe to the bottom.

Maggot was subsequently anaesthetized and after about seventeen minutes was in a very favorable position to start. The first priority was to shape and fit the plate to the nail, (I had previously altered the shape of the plate and roughly fitted it earlier to save time) when this was completed the area of attachment was thoroughly cleaned using the Dremel with an attached sanding drum. The plate was then placed on the nail and the holes were drilled in the nail wall for the reception of the screws, a small hand drill was used and a marker placed on the drill bit 6mm from the tip to prevent overdrilling. Plate and toenail were then degreased with acetone and made ready for the attachment. One screw each side of the crack located the plate in position then **Bond-N-Flex**® was applied under the plate and in the screw holes. This was then given a little while to activate and when it was starting to harden the other screws were placed in the pre-selected holes and screwed up to secure the whole area around the crack. The whole area of the nail wall distal to the attached plate (including the deformed laminae underneath) was then trimmed back as far as was possible to allow the nail to grow down without any loading or pressure.
